From: David P. Best david@davidpbest.com  
Subject:  
Date: November 7, 2020 at 9:21 PM  
To:

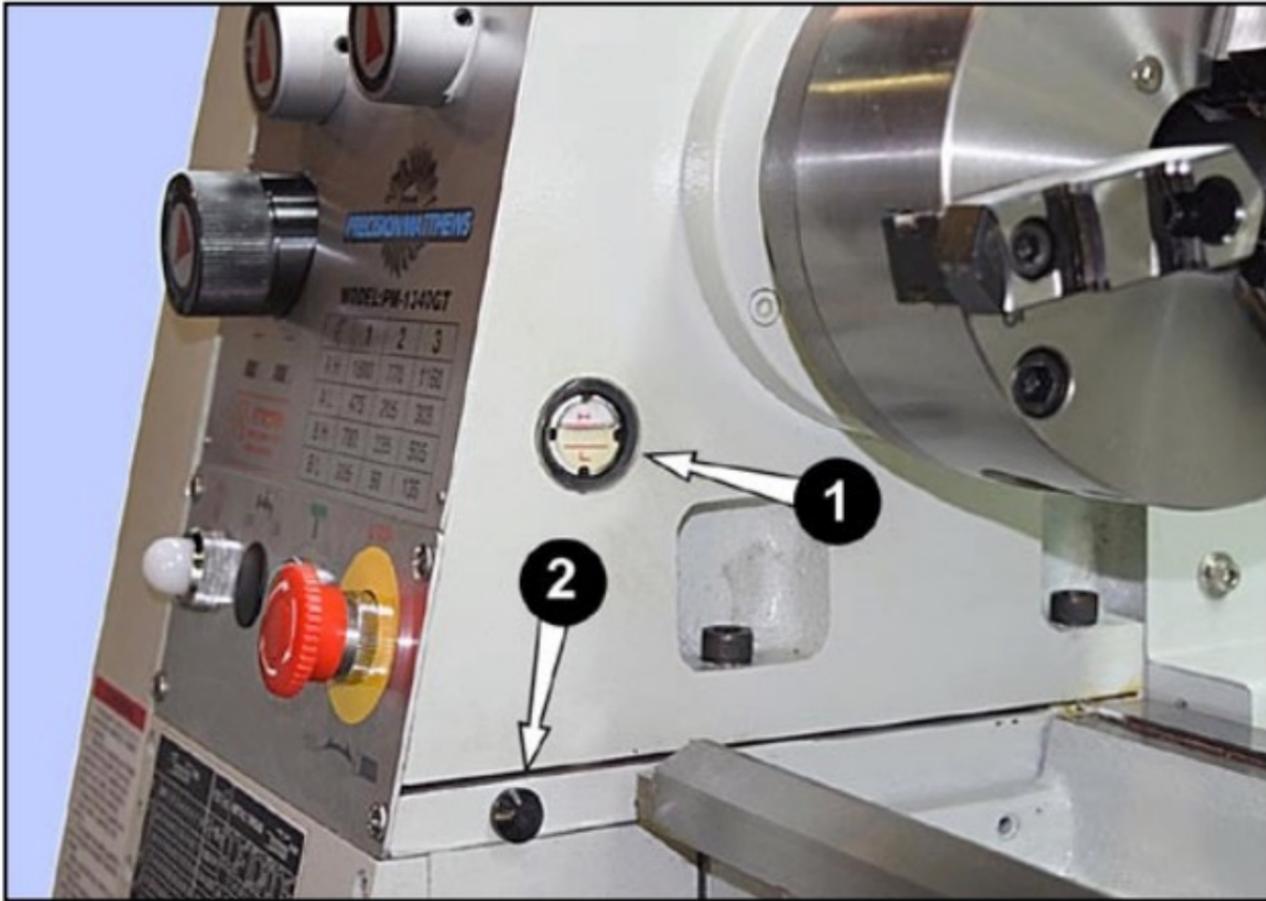
First, what convinced me to do it was the crappy (unnoticed) oiler port for the drive shaft bearings. Shown here as #2 in the new manual (which I didn't have when I started the project):

That oil port is responsible for getting oil to the bearings for the threading lead screw, but most importantly, for the drive shaft that turns the feed shaft to the apron just below it. If you fail to oil that port, the drive shaft will seize up, and since the clutch is downstream from the gear shaft inside the Norton change box, the result is that the main change gears (under the cover one the left side of the machine) will start to grind, and you end up with broken teeth on those gears. Been there done that. After my change gears had been badly damaged, I decided a complete diagnosis was required.

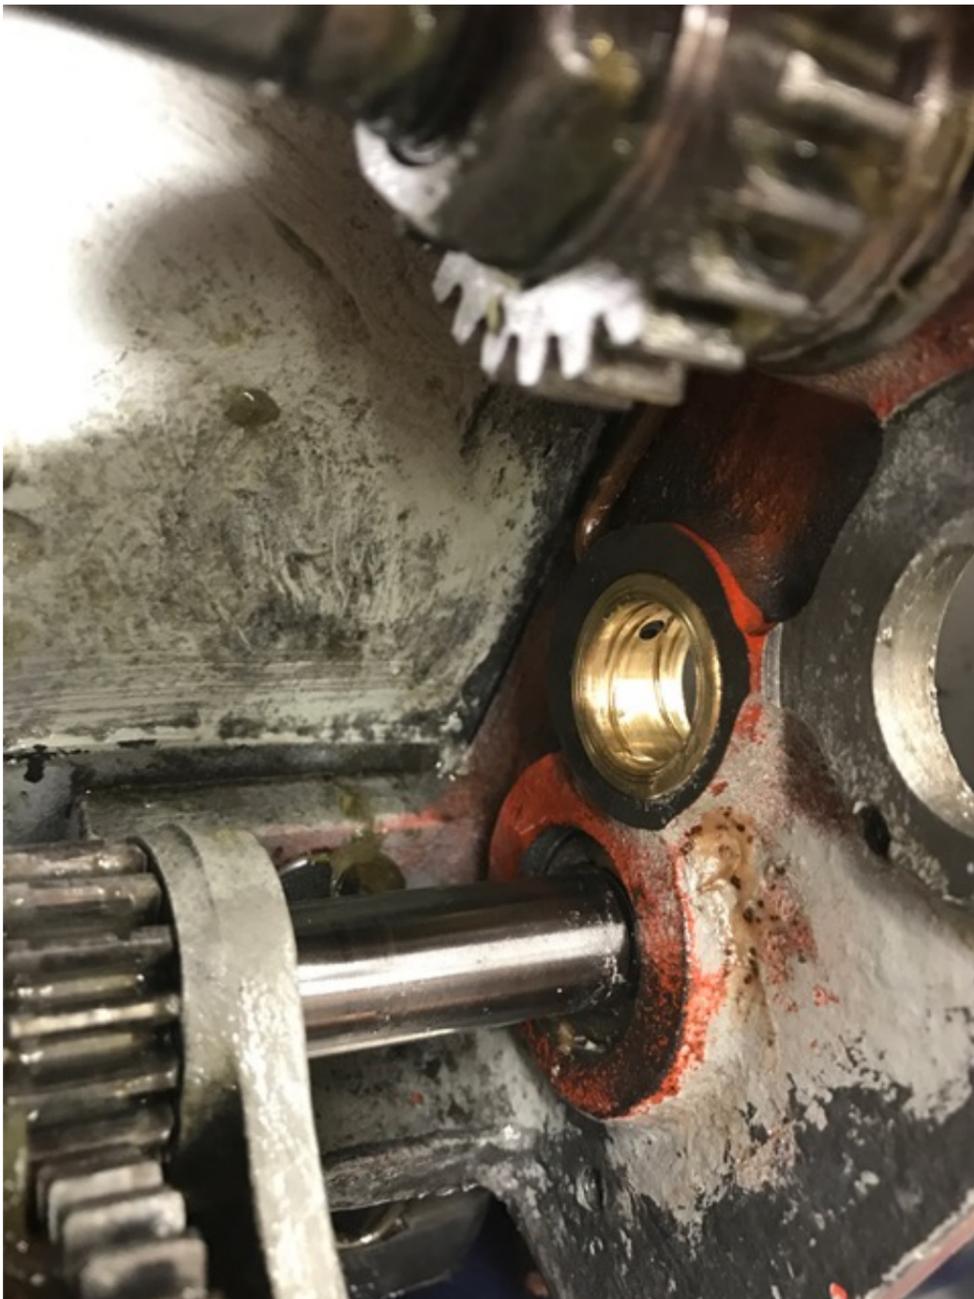
When I got into what was going on, I had to completely disassemble the Norton gearbox. Getting the gear shaft that turns the feeding shaft out of that gearbox was a major effort. Once I got it out, I saw why. The bearing for that gear shaft is a bronze bushing with a spiral oil recess fed by a tiny copper tube from the oil port tray above. On my lathe, something nasty had gotten into that bearing and turned to hard tar. Here's what that bearing looks like once I got all the tar and crap out of it (if you look closely towards the top rear of that bronze bearing you can see the copper tube that feeds it from above):

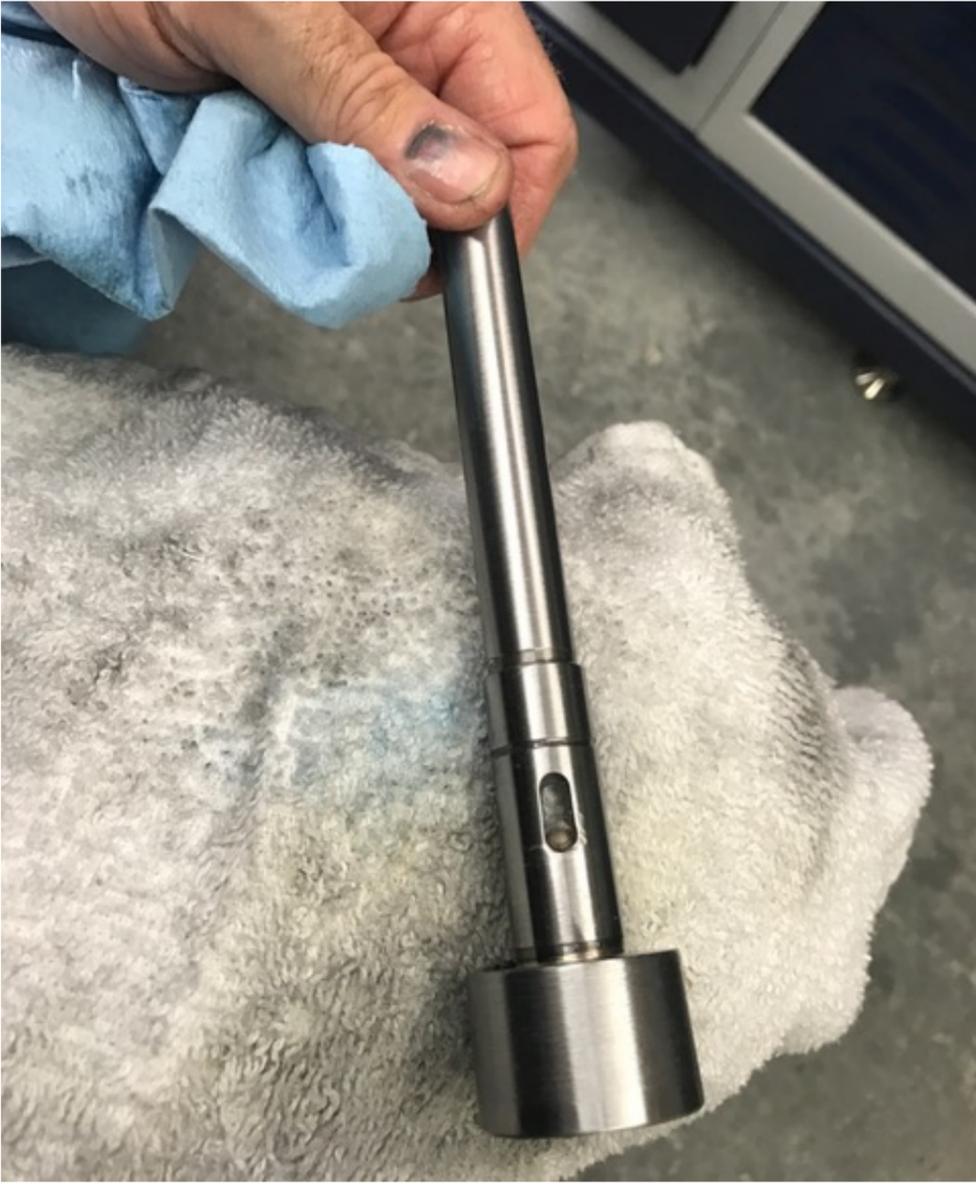
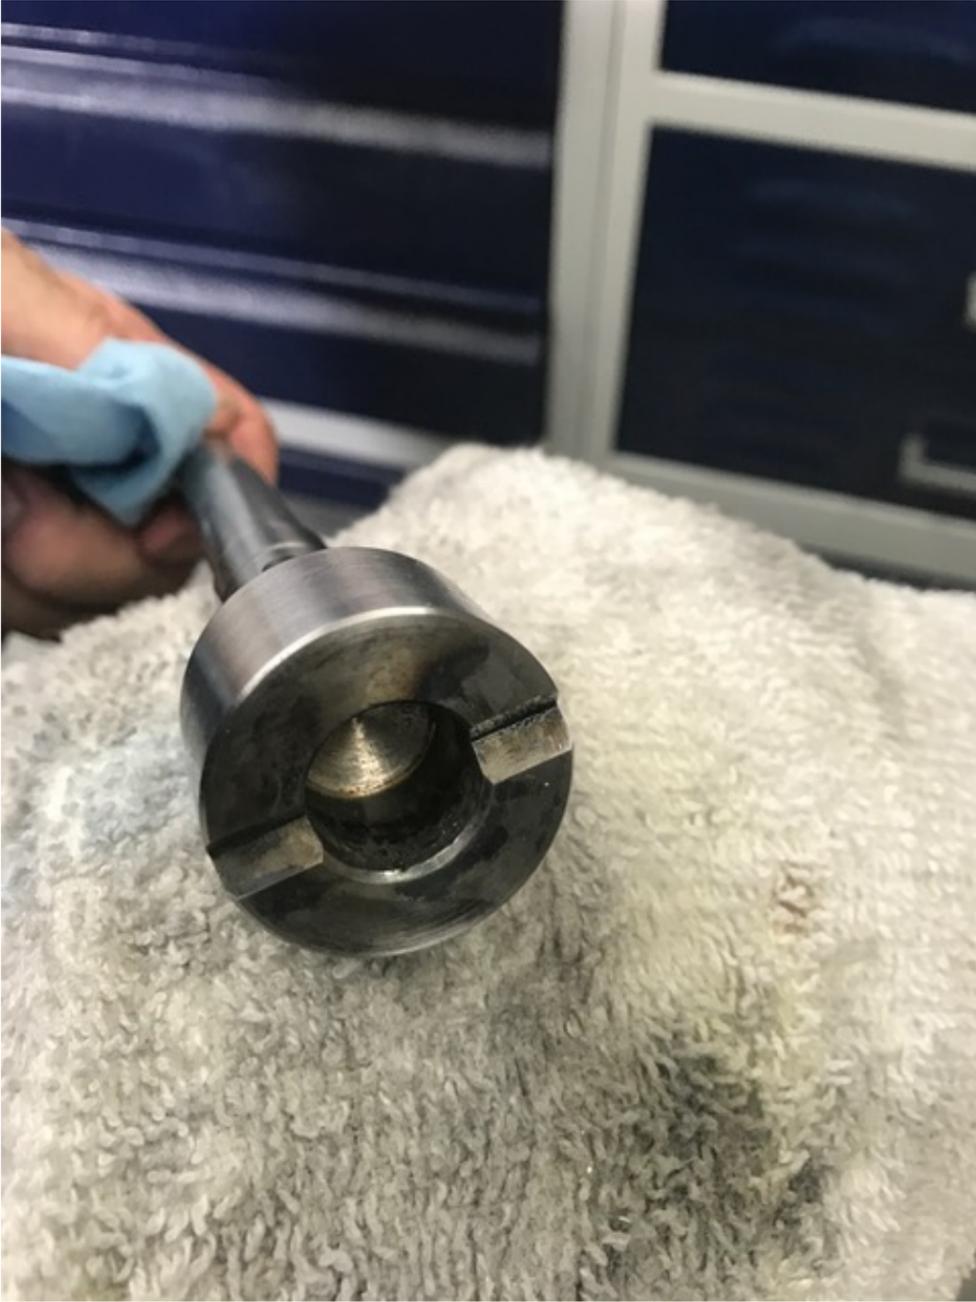
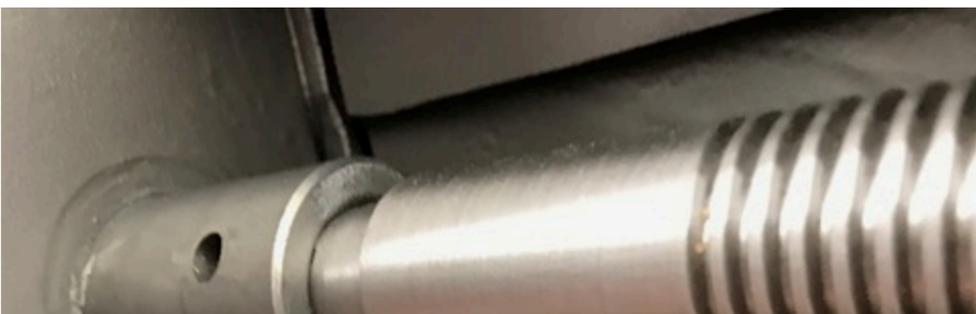
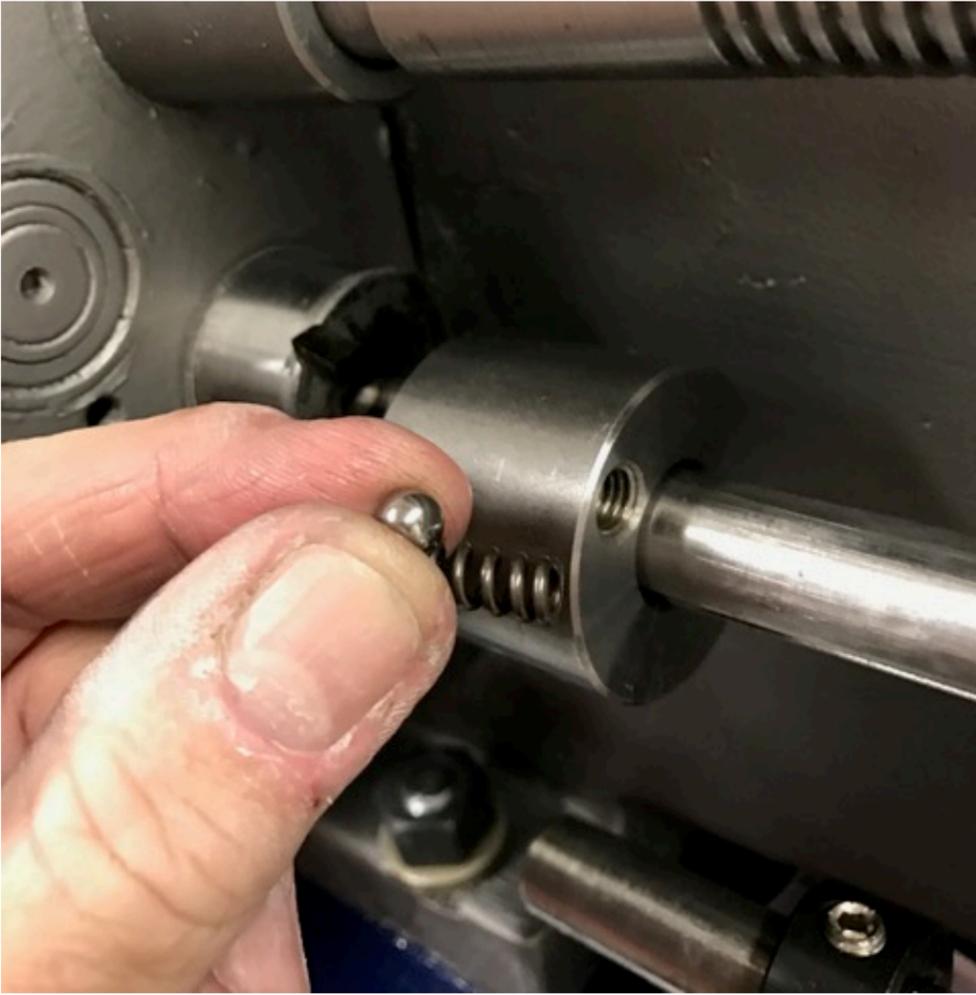
When I got the shaft out and cleaned it up:
