Fixing Y-axis Backlash in PM833-T

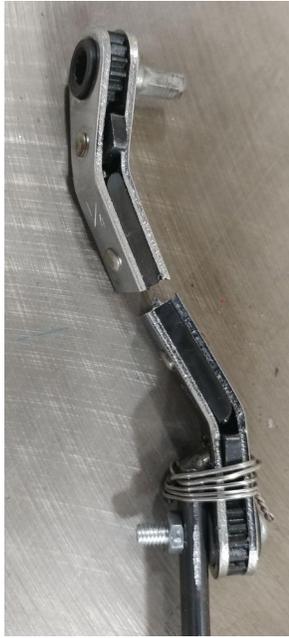
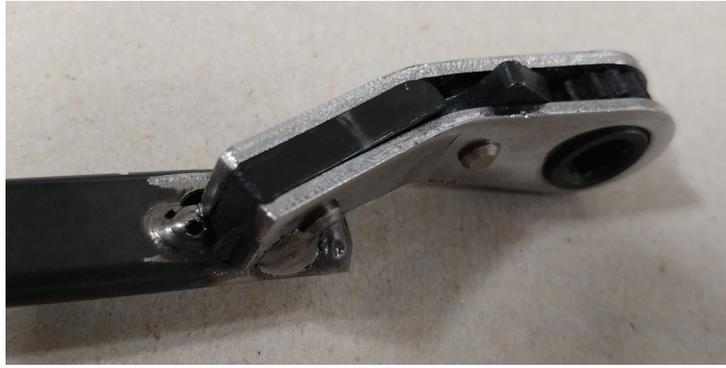
1st attempt failed... The tool was too tall
2nd attempt failed, the ratchet was from Harbor Freight, the black mid material was plastic, the welding destroyed the spring/ball mechanism. Moving to a better tool...

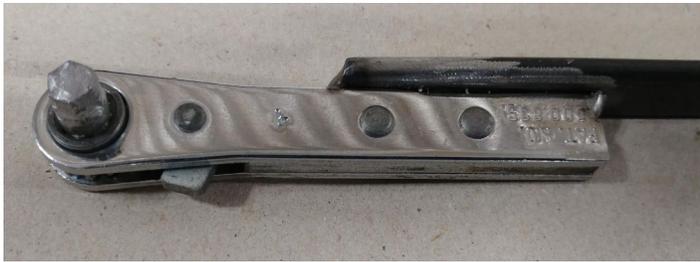
This version worked. I used a better American made tool that was all metal. I recommend using a better ratchet with more steps as the angle of movement is very limited.

Also use a good hardened Allen wrench tip as the torque of the long rod easily destroys softer material.

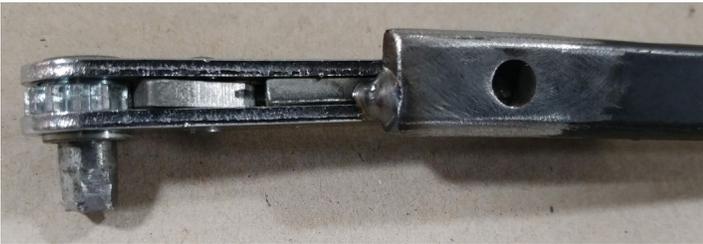
The extension rod I used was from a broken Irwin clamp, it was hardened and I did not want to destroy my band saw blade and I was too lazy to cut it with a grinder. The unused bad end is saved as a reminder of the sometimes shady quality of HF tools.
